Manhole Inspection Summary

Manhole # S49I__014MH

Location Address: **514 S ROSE-MILTON-ALLEY** Cross Street: **EASTERN-FLEET-ALLEY**

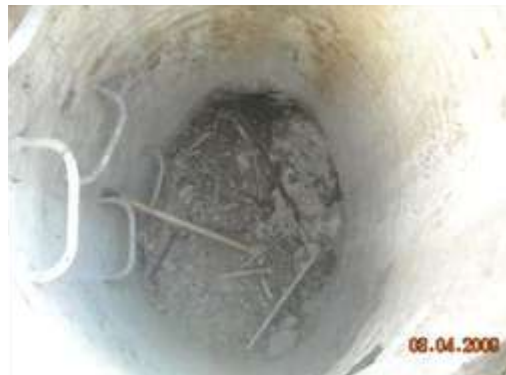
Top View

Comments **USED 16LB MAUL, VINEGAR, AND SPRAY LUBRICANT TO FORCE OPEN MANHOLE COVER; FRAME AND COVER WAS SEALED BY CONCRETE (see photos)**
